**IDRAIM – stream hydromorphological evaluation,  
analysis and monitoring system**

## **Illustrated Guide to the Answers**

**Guidebook for the evaluation of stream morphological  
conditions by the Morphological Quality Index (MQI)**

**Version 1.1**

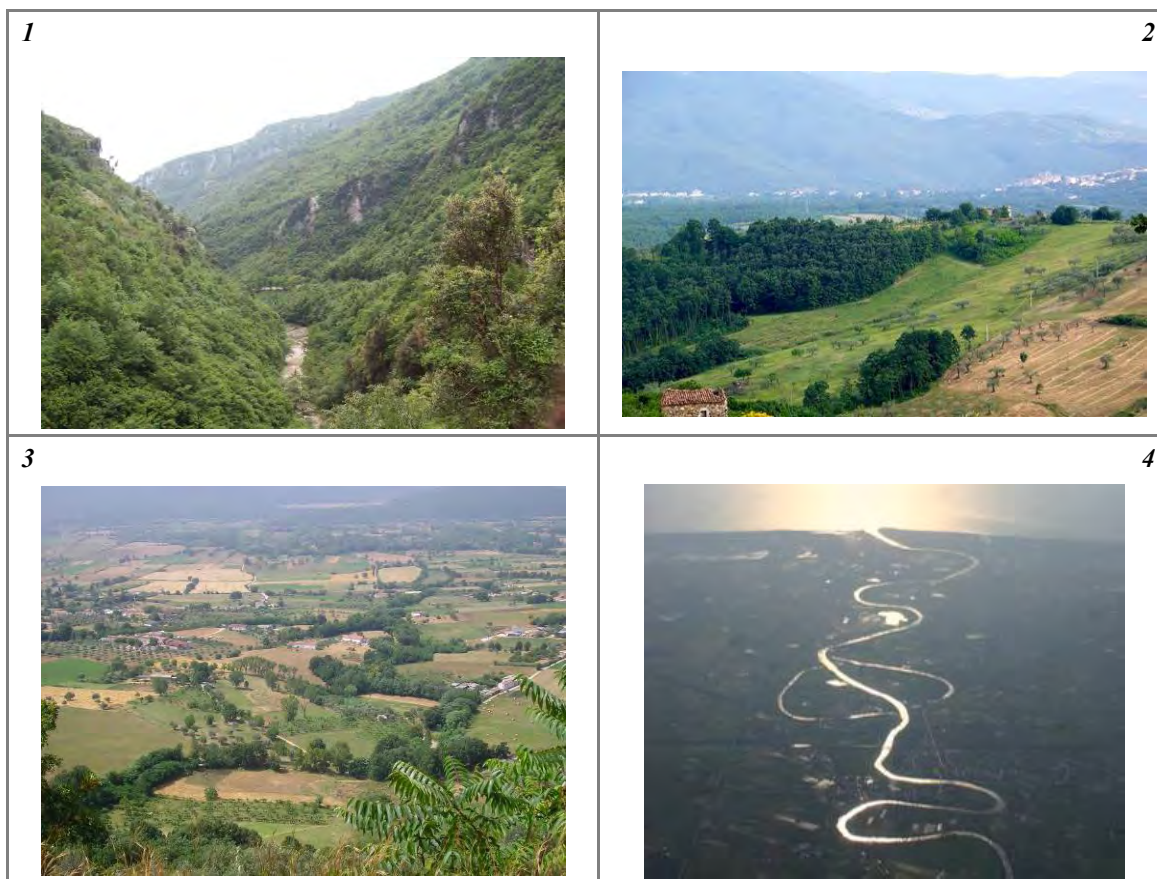
**Figure 2** – Panoramic views of the physiographic units in the Volturno River watershed. (1) Mountainous unit; (2) Hilly unit; (3) Intermontane unit; (4) Low plain unit.

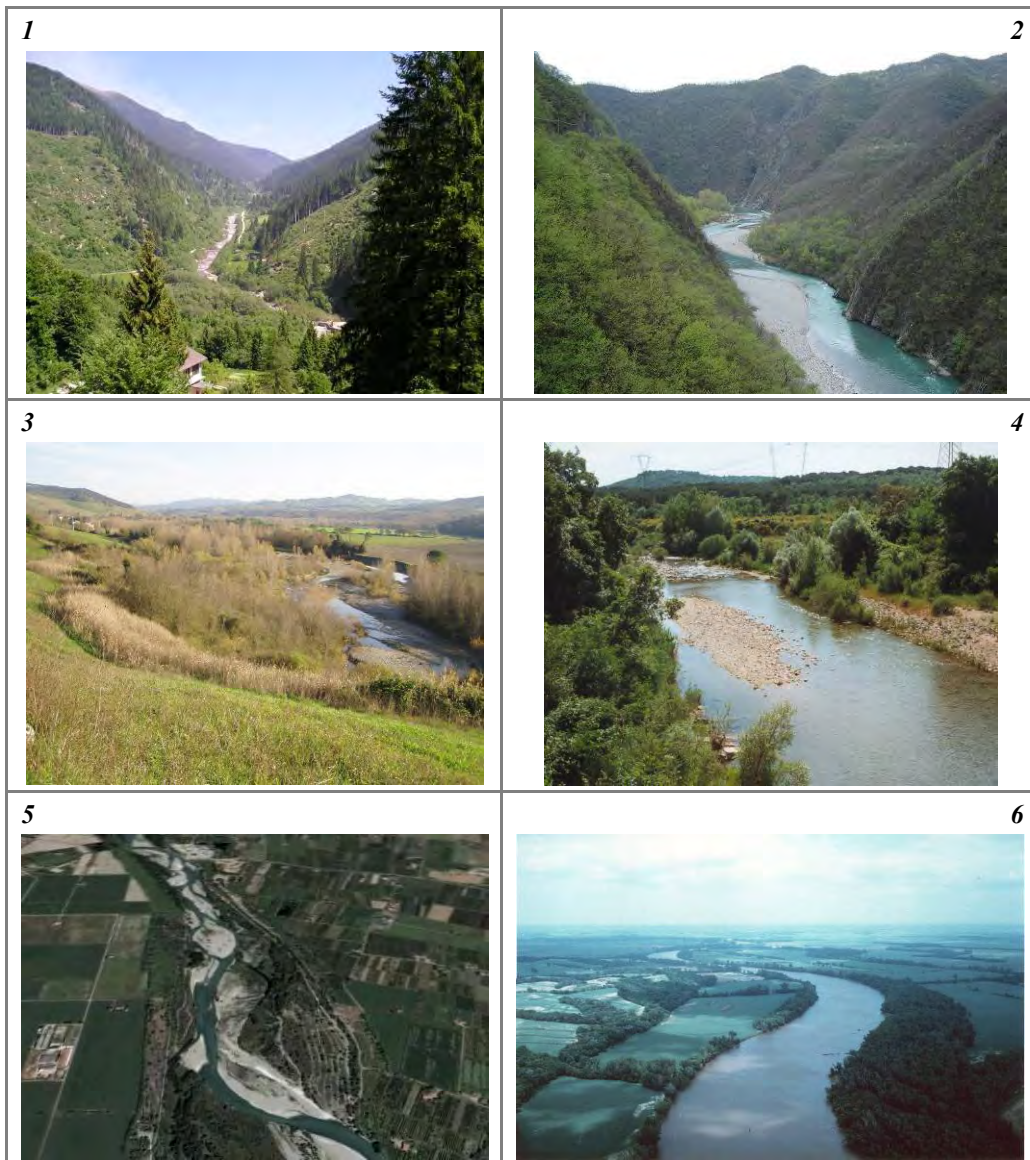
**Figure 4** – Examples of different confinement classes. (1), (2) Confined channels; (3), (4) partly confined channel; (5), (6) unconfined channels.

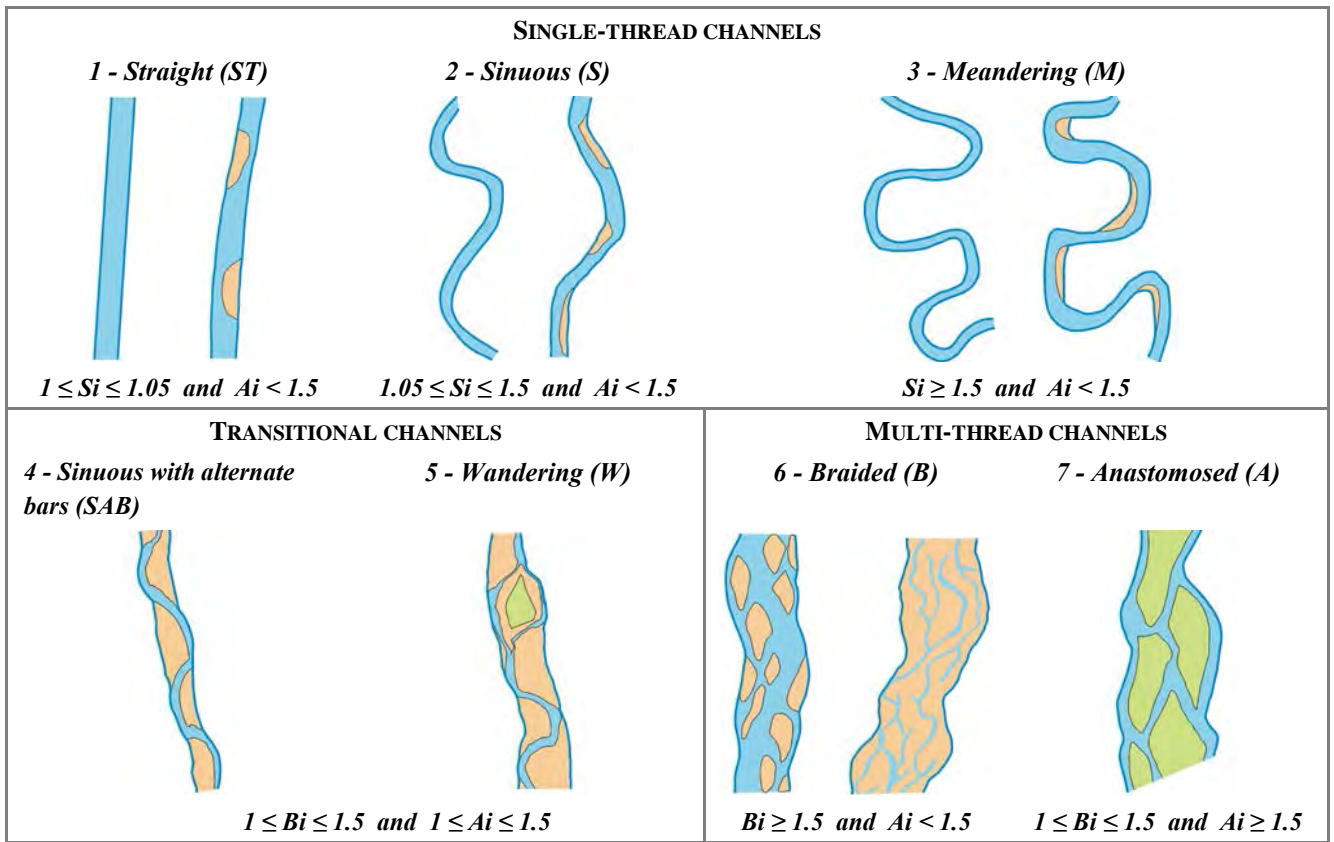
**Figure 5** – Morphologies of partly confined and unconfined channels. *Si*: sinuosity index; *Bi*: braiding index; *Ai*: anastomosing index.

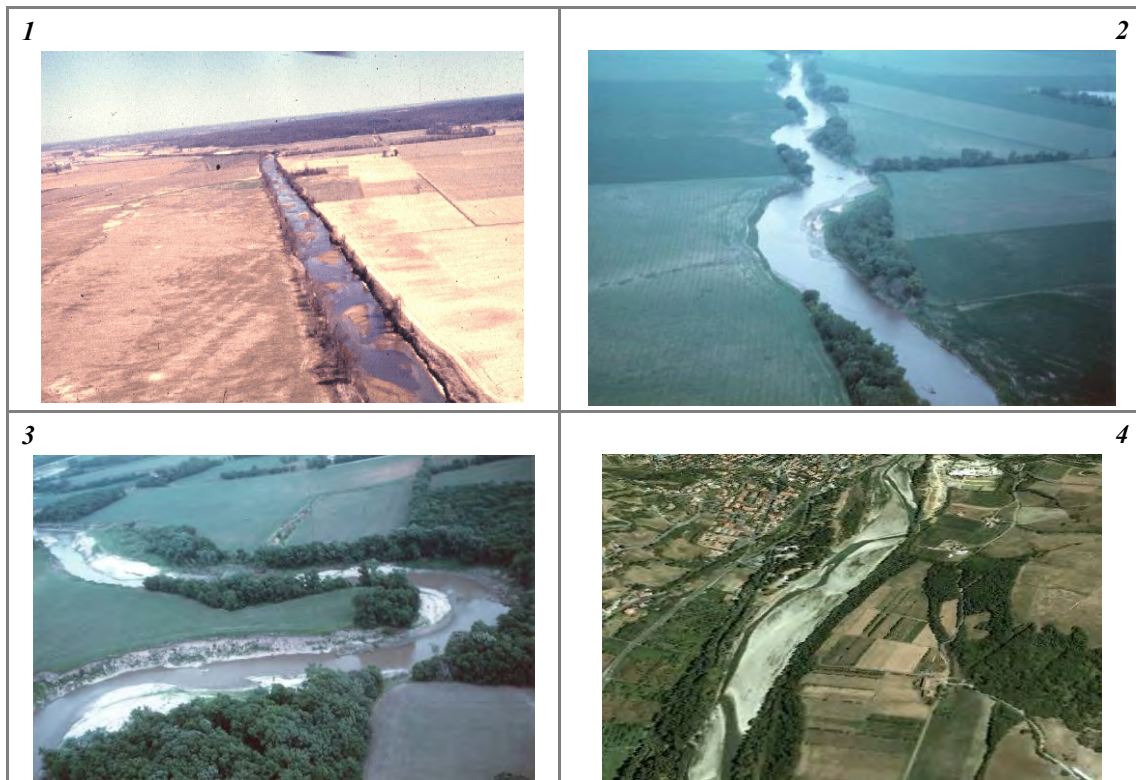
**Figure 6** – Examples of morphologies of partly confined and unconfined channels. (1) Straight; (2) sinuous; (3) meandering; (4) sinuous with alternate bars.

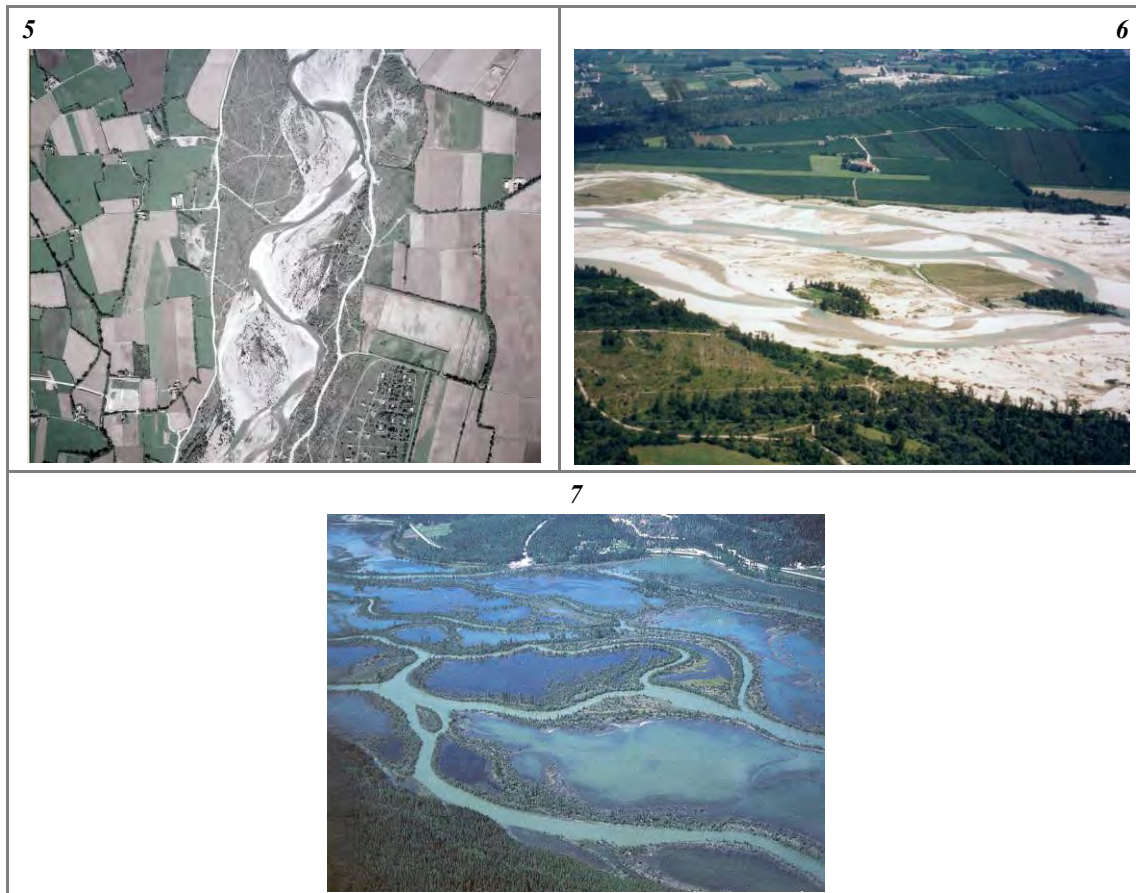
**Figure 6 (continued)** – Examples of morphologies of partly confined and unconfined channels. (5) Wandering; (6) braided; (7) anastomosing (the islands and floodplain are inundated).

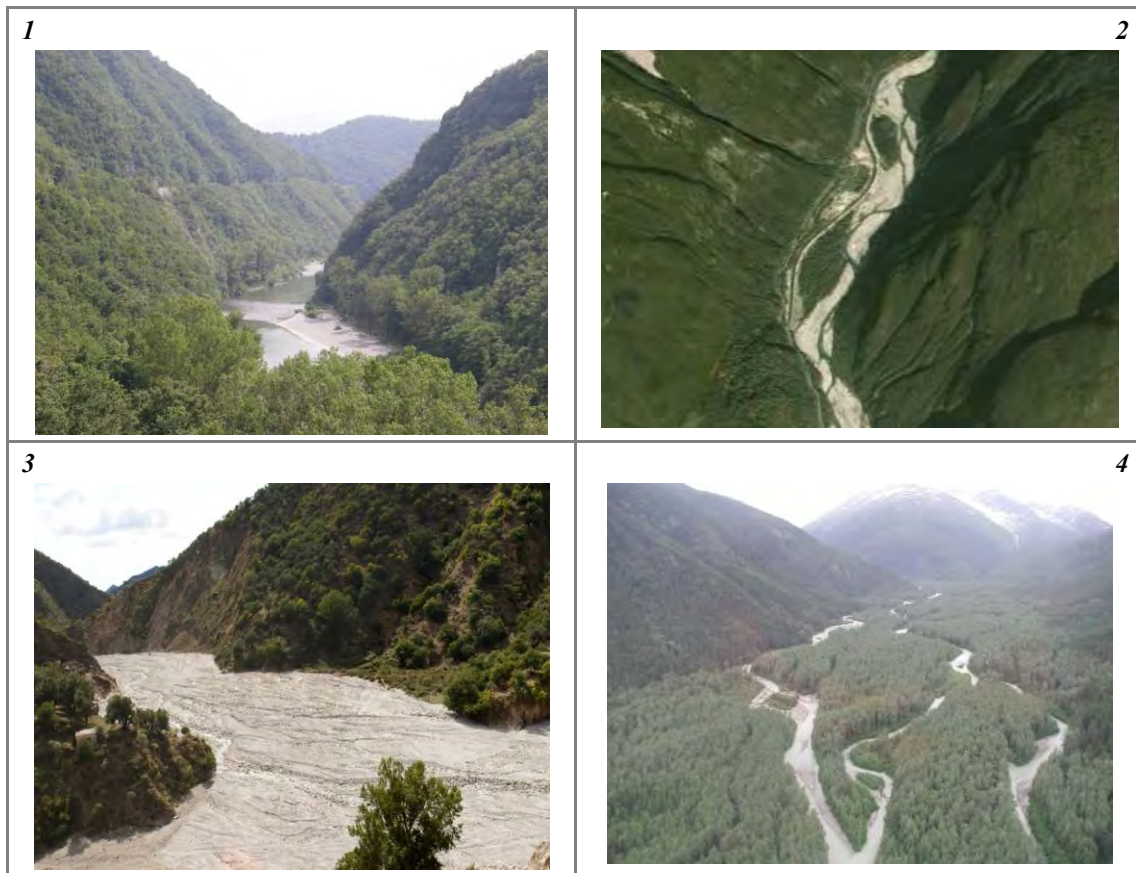
**Figure 7** – Morphologies of confined channels. (1) Confined single-thread; (2) confined wandering; (3) confined braided; (4) confined anastomosed.

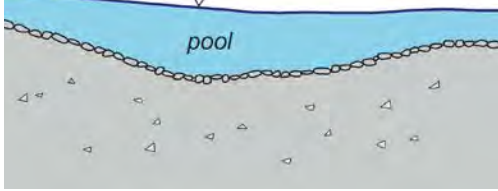
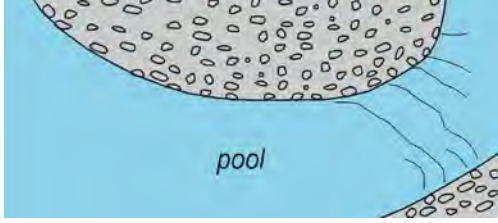
<b>Pool</b>

**Figure 8** – Main morphological units of steep alluvial channels (modified from Halwas & Church, 2002).

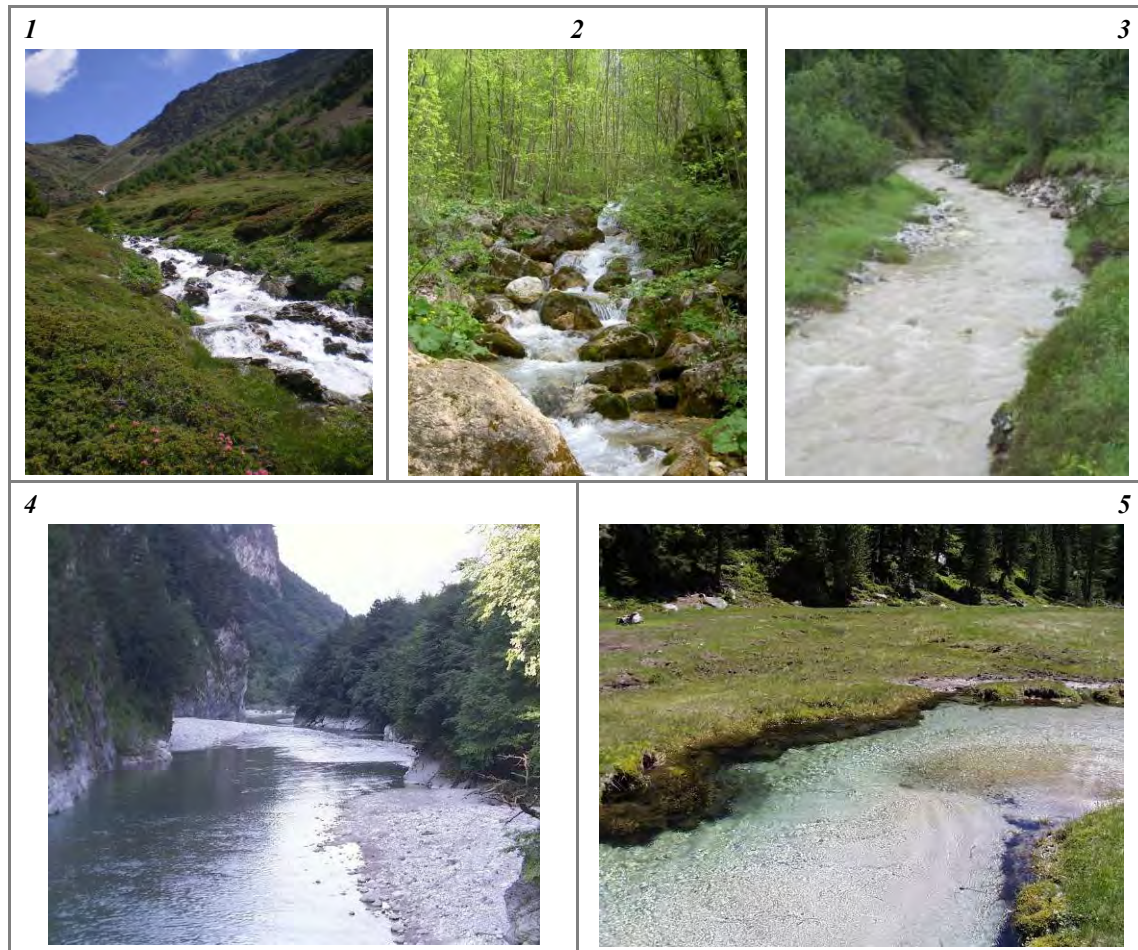
**Figure 12** – Reach-scale morphologies in single-thread, alluvial channels. (1) *Cascade*; (2) *step pool*; (3) *plane bed*; (4) *riffle-pool*; (5) *dune-ripple*.

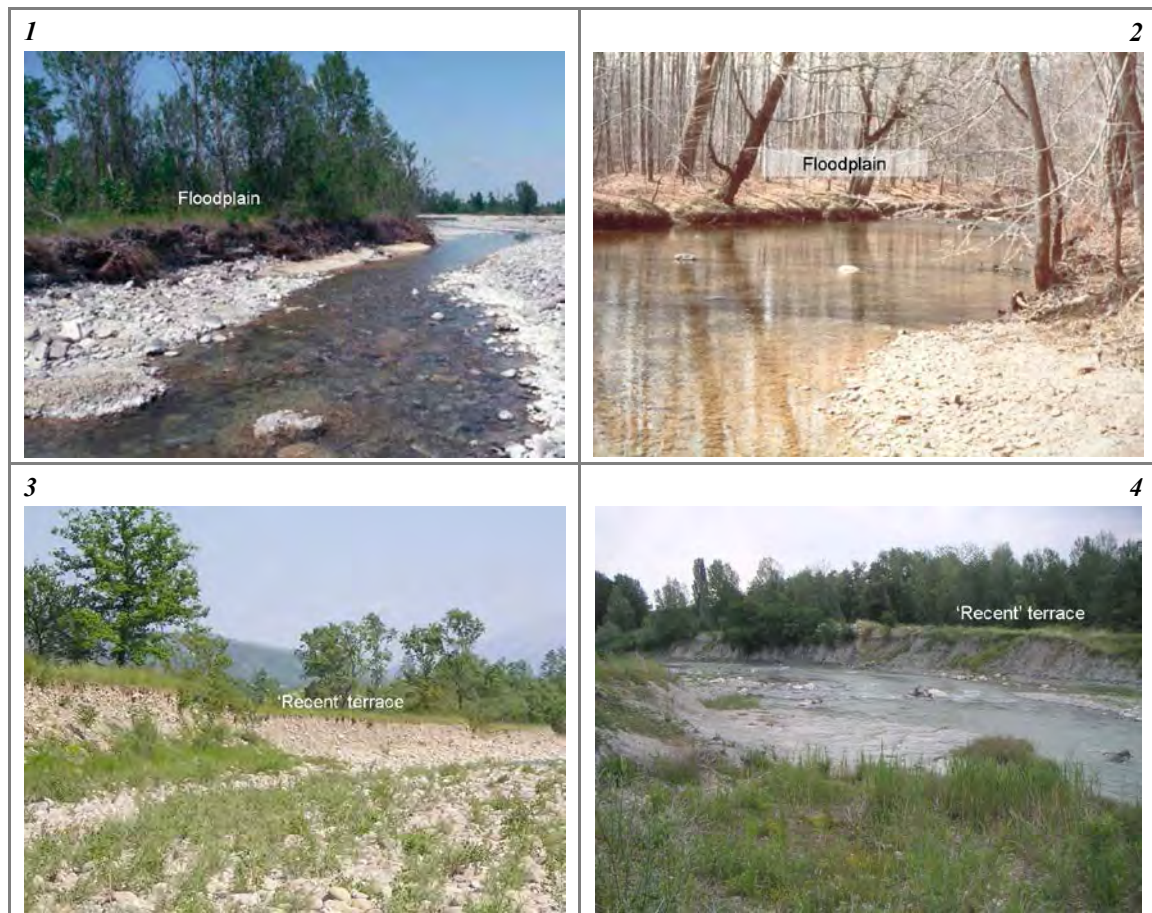
**Figure 23** – Differences between floodplain and “recent” terrace. (1) and (2) Examples of modern floodplain (note the very limited differences in elevation with channel bars); 3: “recent” terrace generated by a bed incision of about 2÷3 m; 4: “recent” terrace generated by an intense incision (> 3 m).

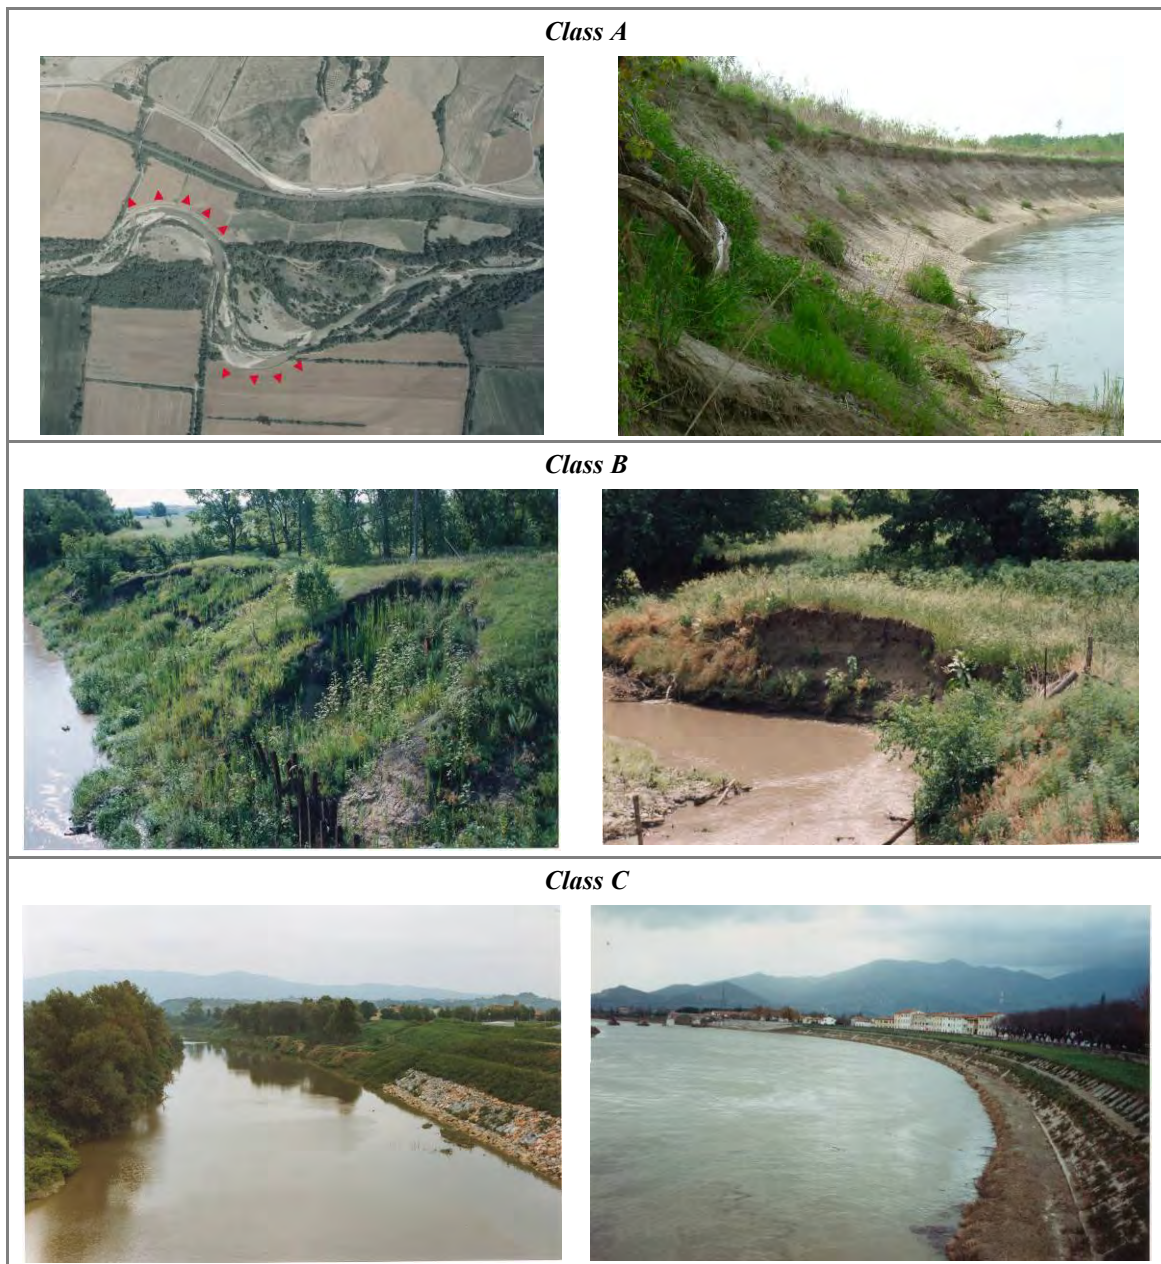
**Figure 32** – Processes of bank retreat. *Class A*: frequent retreating banks, particularly along the outer side of bends (red arrows, photo on the left). *Class B*: this class includes reaches with bank erosion observed only locally. *Class C*: absence of eroding banks due to bank protections and/or absent channel dynamics.

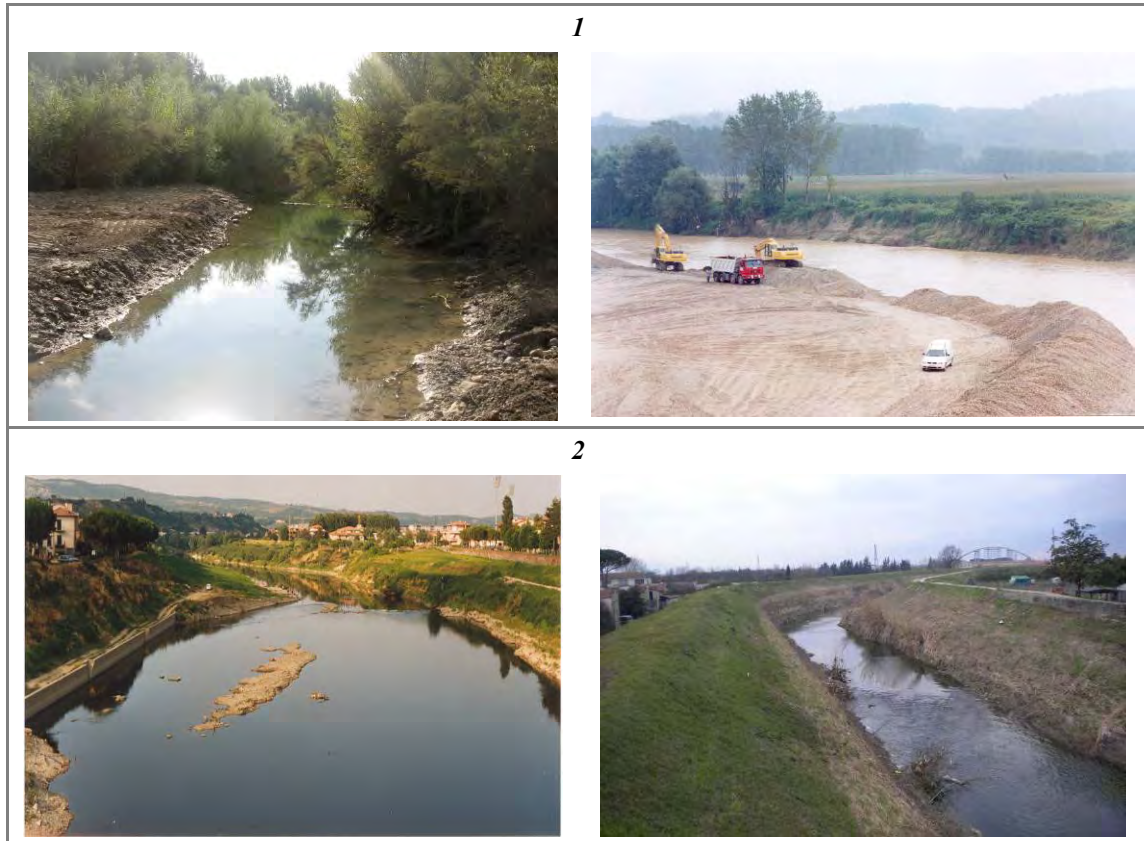
**Figure 40** – Alteration of cross-section variability in partly- and unconfined channels. (1) Cases of partial homogenization of the cross-section due to interventions. (2) Cross-section homogeneity extended for long reaches due to excessive artificiality.

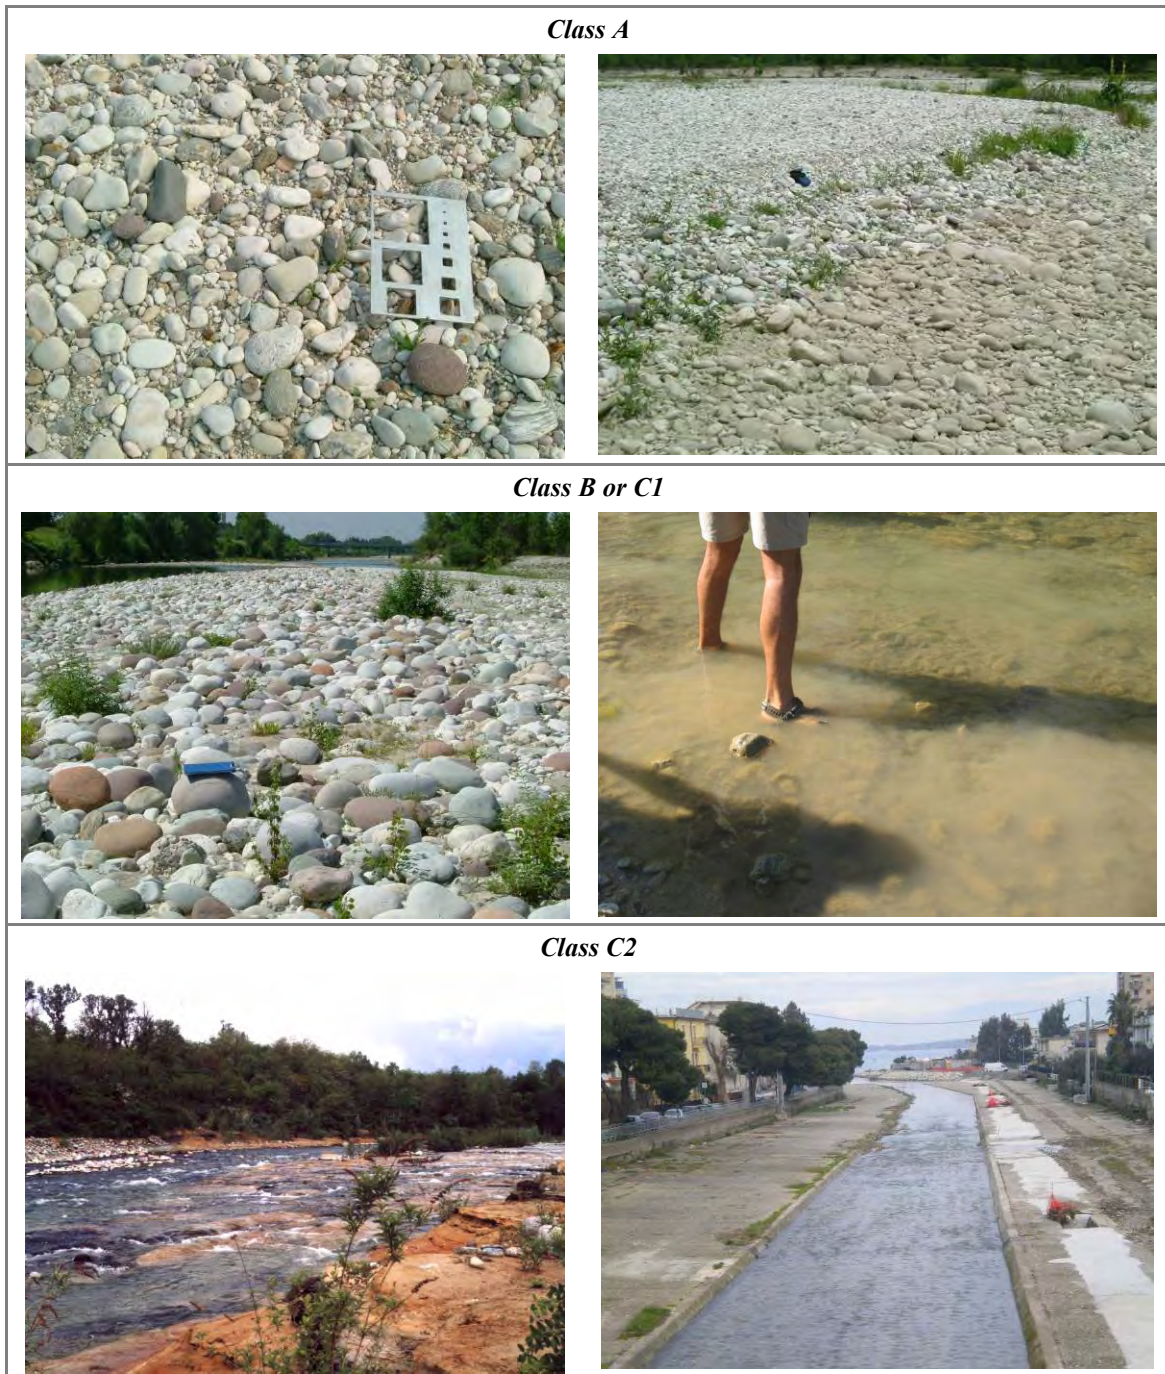
**Figure 44** – Alterations of substrate in partly- and unconfined channels. *Class A*: natural sediment heterogeneity in an unconfined channel. *Class B* or *C1*: presence of armouring (photo on left) or clogging (photo on right) (assignment to *Class B* or *C1* will depend on the extension of armouring and/or clogging along the site). *Class C2*: bedrock outcroppings due to bed incision (photo on left) or completely altered substrate because of bed revetment (photo on right).

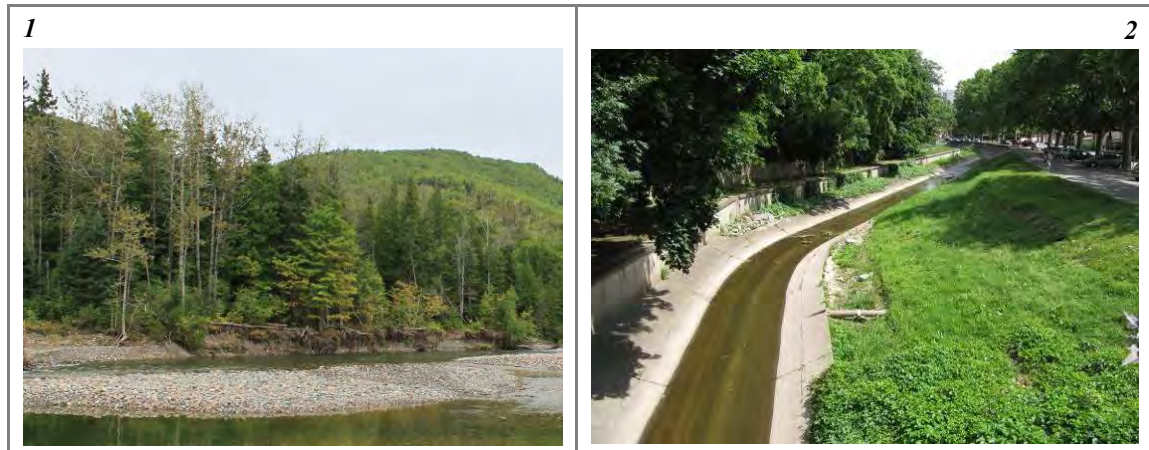
**Figure 46** – Vegetation in the fluvial corridor. (1) Presence of vegetation connected with the channel in a partly confined reach; (2) absence of vegetation (right) or vegetation disconnected by the stream channel because of the presence of walls.

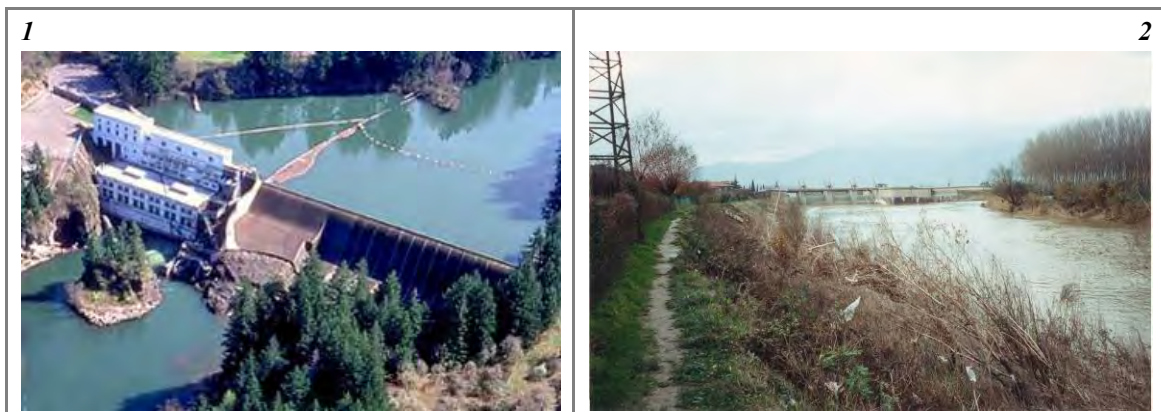
**Figure 52** – Alteration of flows. Typical alteration structures. (1) Dam; (2) spillway.

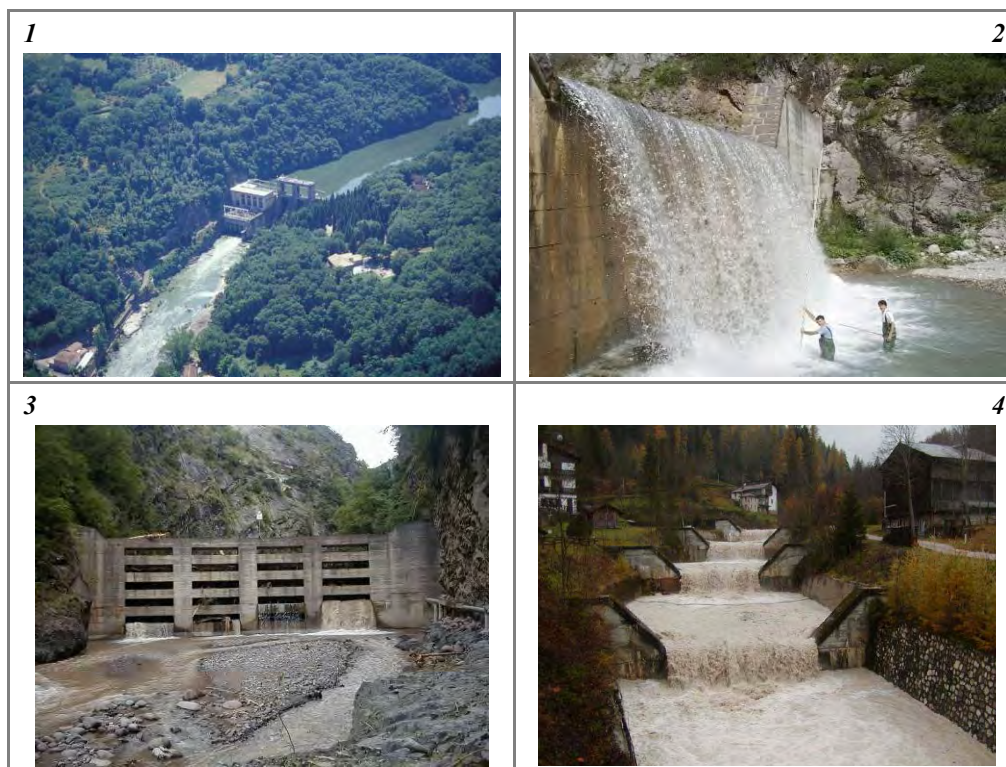
**Figure 55** – Transversal structures of alteration of sediment discharges in mountain areas. (1) Dam; (2) retention check dam; (3) open check dam; (4) sequence of stepped consolidation check dams.

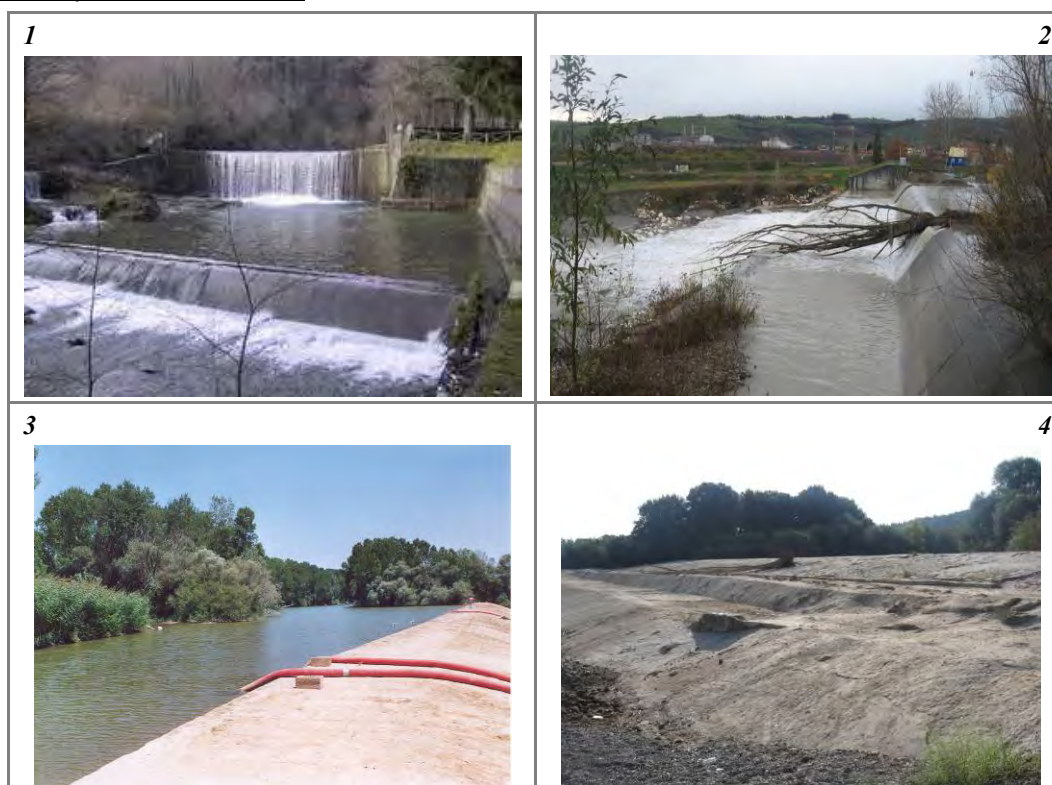
**Figure 56** – Transversal structures of alteration of sediment discharges in hilly and lowland areas. (1) Consolidation check dam; (2) abstraction weir; (3) not filled abstraction weir; (4) filled abstraction weir.

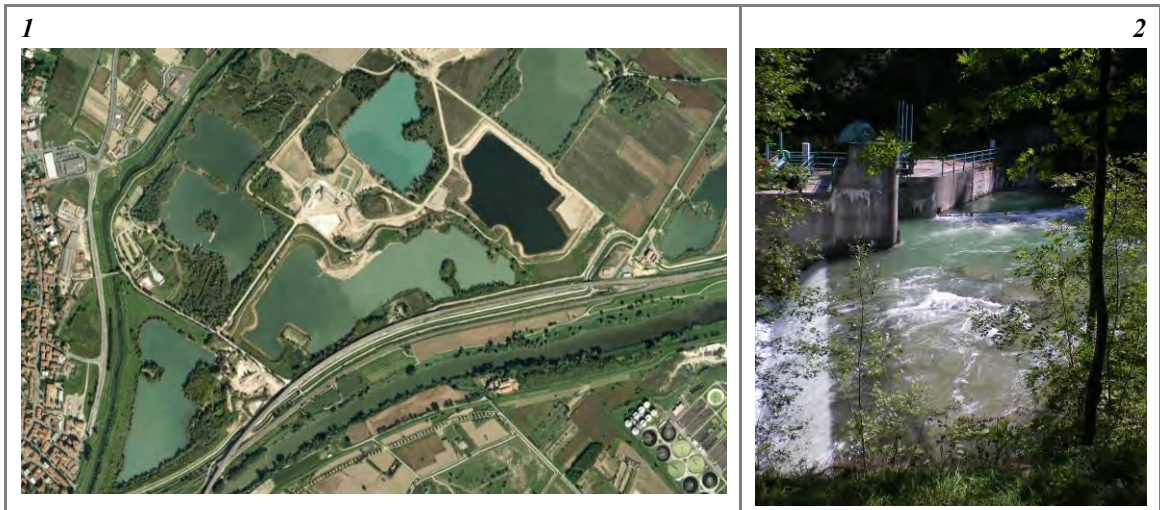
**Figure 58** – Other structures (besides those defined for A1) that can cause an alteration of flows within a reach. (1) Retention basins; (2) discharge abstraction.

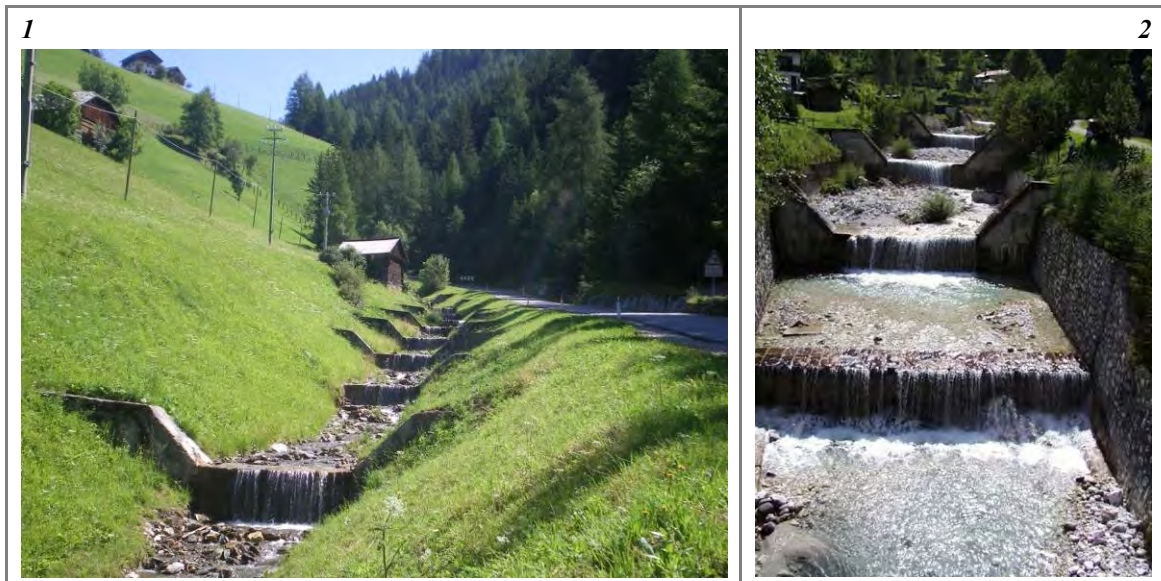
**Figure 62** – Cases with very high density of transversal structures ( $> 1$  every 100 m in mountain areas): an additional score of 12 is applied.

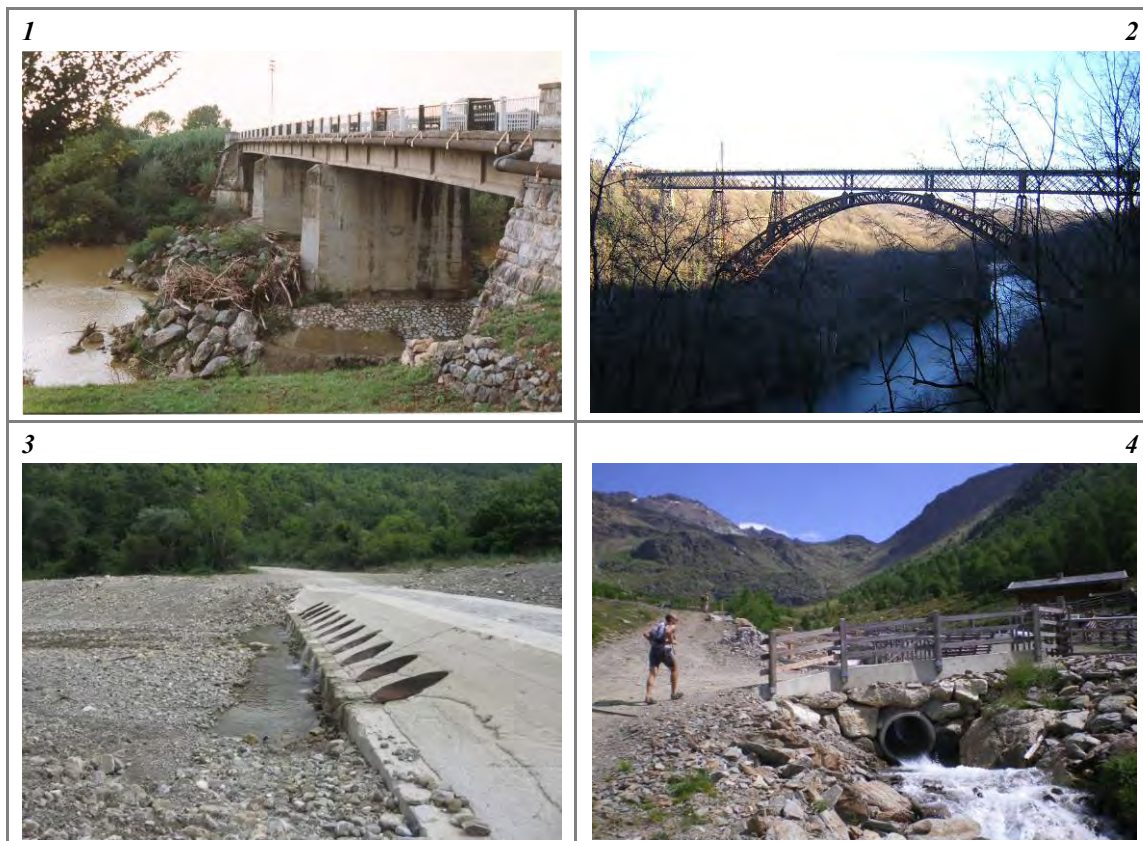
**Figure 63** – Crossing structures. (1) Bridge with interference on fluvial dynamics; (2) crossing structure unrelated to the fluvial corridor; (3) ford with culverts; (4) culvert.

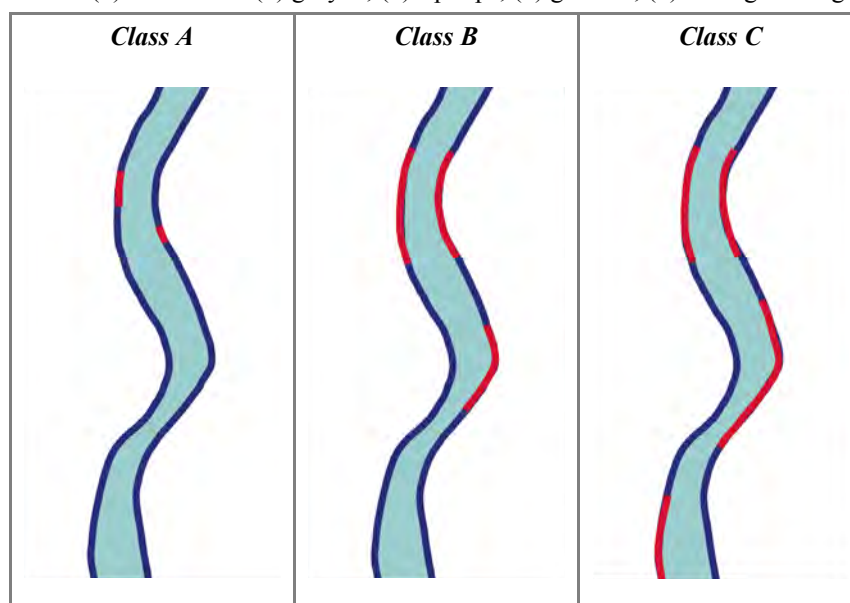
**Figure 66** – Bank protections. *Class A*: localized protections (red lines); in the example the structures are 4% of the total length of the two banks. *Class B*: significant presence of bank protections ( $\leq 33\%$ ); in the example they are about 30% of the total length of the two banks. *Class C*: relevant presence of bank protections ( $> 33\%$ ); in the example they occupy about 50% of the total length of the two banks.

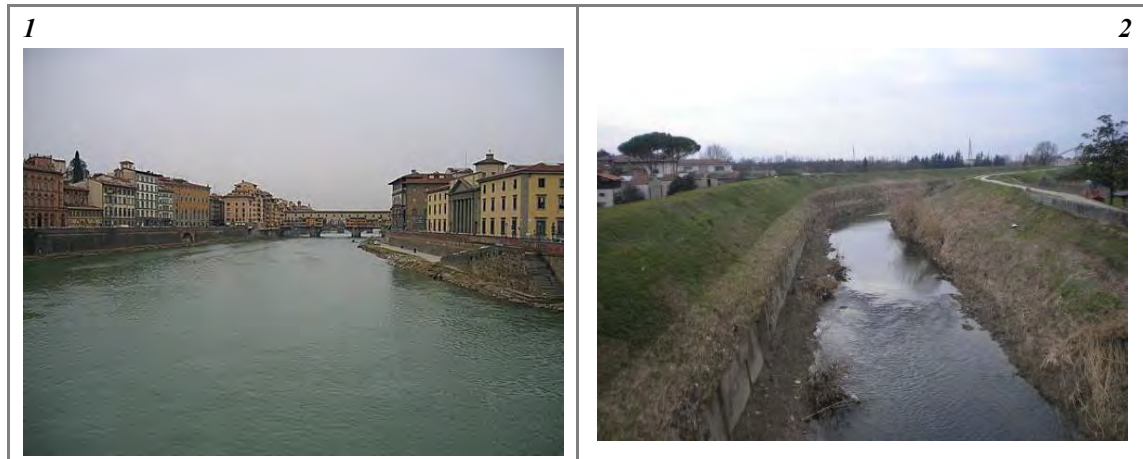
**Figure 70** – Cases of bank protections plus levees in contact occurring for most of the reach (> 80%), for which a score of 12 is added.

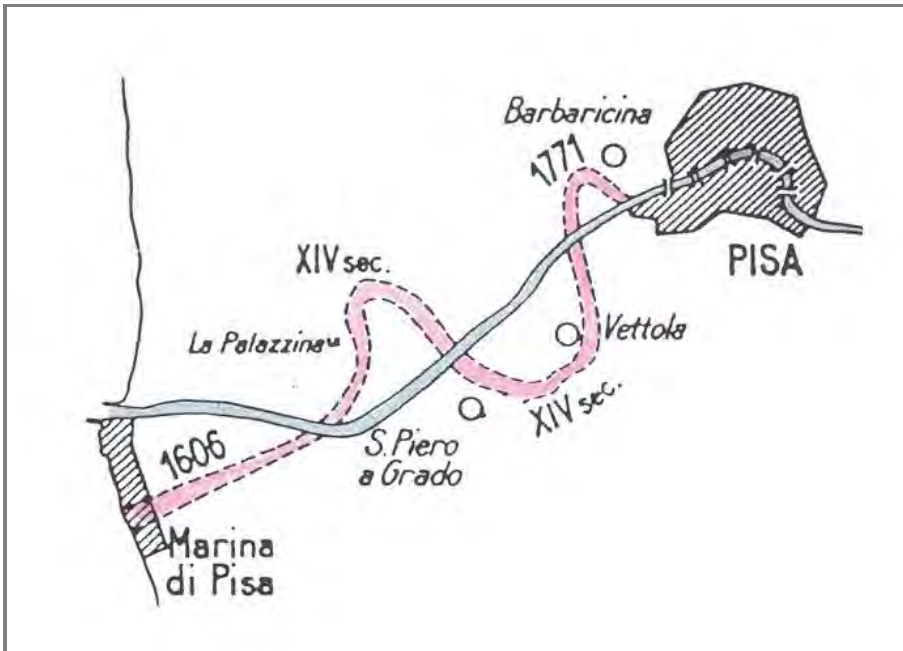
Figure 71 – Artificial changes of river course. Example of well known artificial changes (meander cut-offs, change of position of river mouth) occurring in historical times.

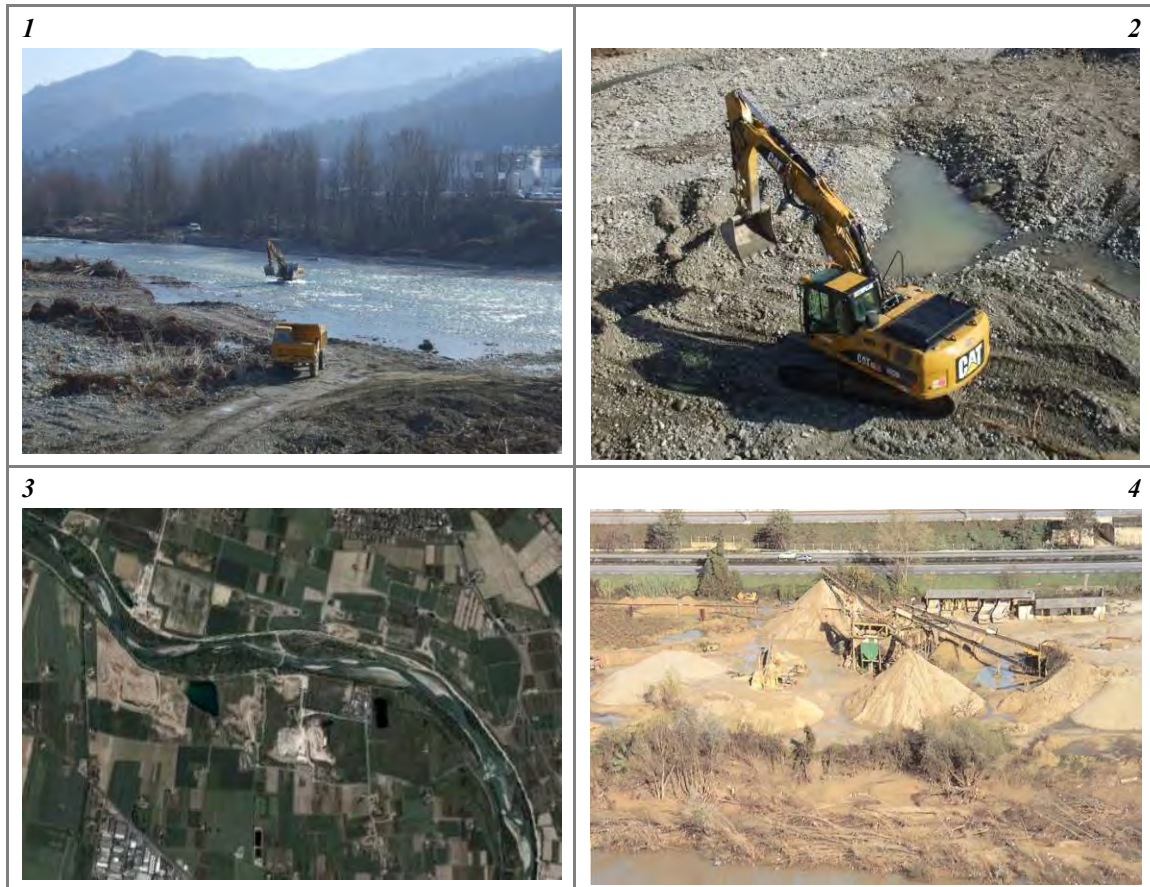
**Figure 75** – Sediment removal. (1) and (2) Recent and present activity; (3) and (4) indirect indicators of intense past activity are the presence of mining sites. Assignment to *Class B* or *C* depends on the extension of the activity (localized or widespread), in the case of confined channels, and on the intensity of the mining activity either in the past and in recent times, in the case of partly- and unconfined channels.

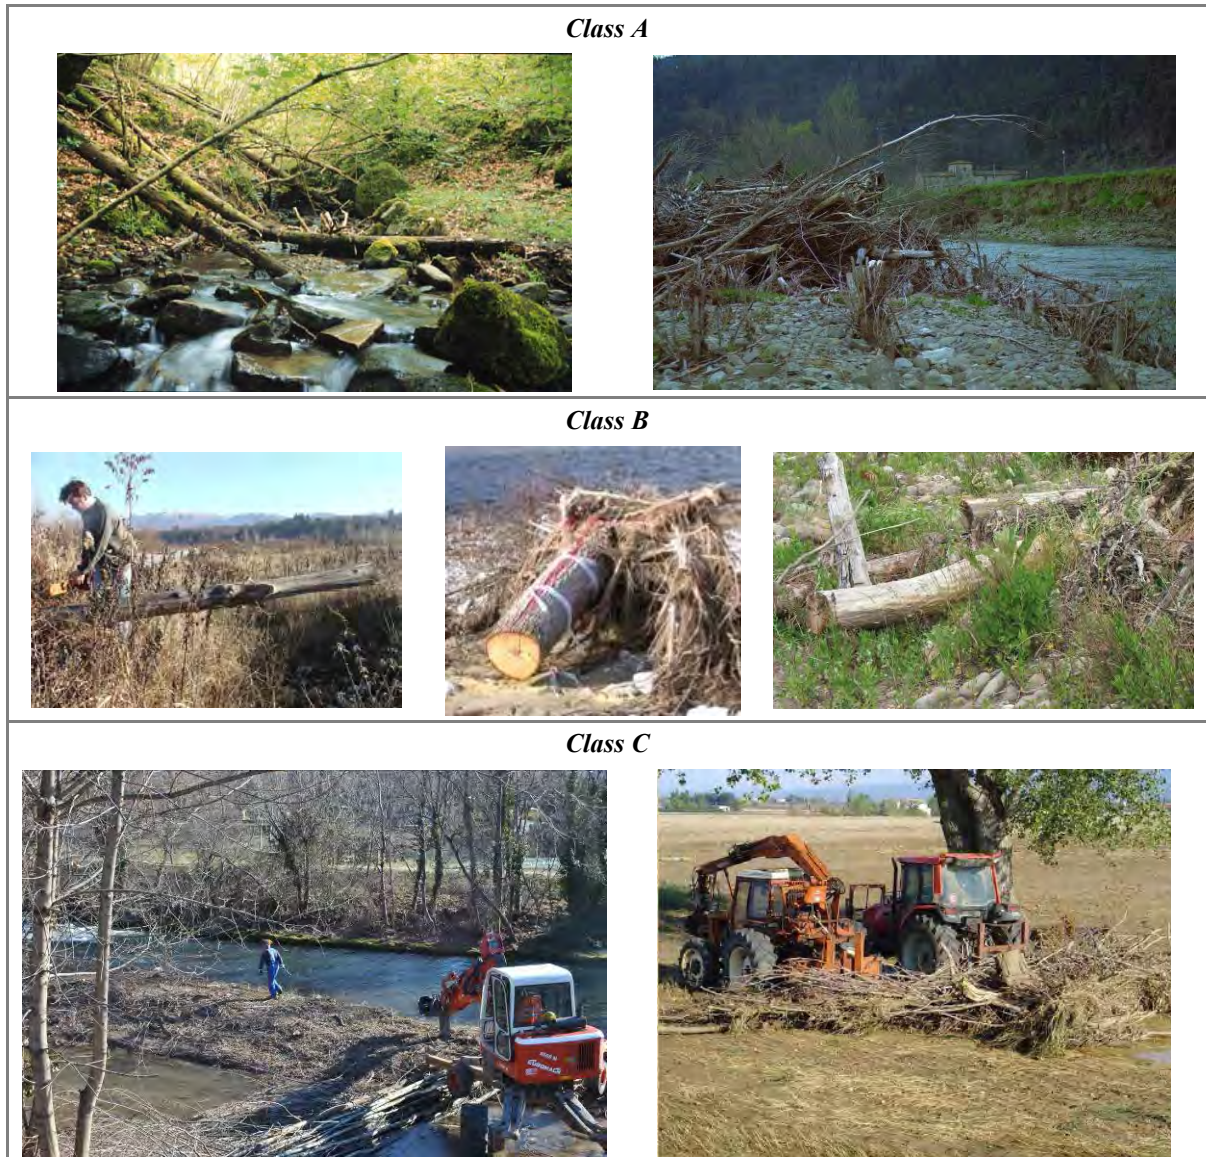
**Figure 76** – Wood removal. *Class A*: absence of interventions of wood removal. *Class B*: partial removal, including removal by private citizens. *Class C*: total removal by public agencies (on the left: photo courtesy of R. Gallo).
